**SYS Meldung im Display
CCM Fehlercode 72 und 74**

Vehicle: All Technical Service Bulletins
Aftermarket Radio May Set DTC'S 72 and 74 In CCM

Number: 93-68-9A

Model and Year:
1990-93 CORVETTE

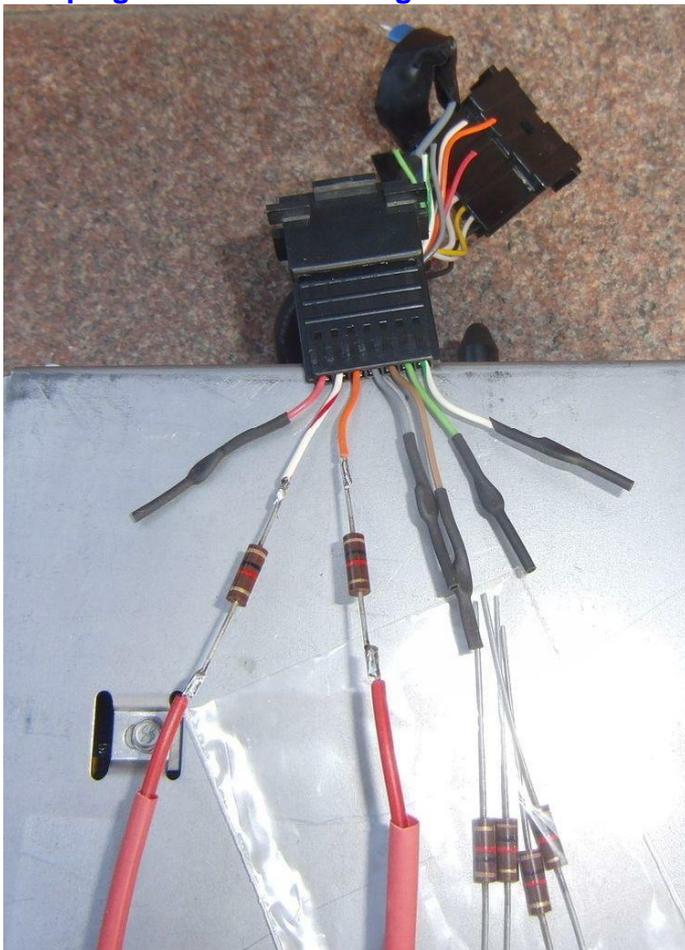
**Es werden zwei 1 k Ohm 0,5 Watt Widerstände benötigt die dann
im Kabel eingebaut werden müssen, siehe Foto C4 1990 nicht Bose System**

Das andere Ende vom Widerstand wird auf + 12 Volt Zündung angeschlossen.

Der Stecker ist vom alten original Radio.

**Two 1 k Ohm 0.5 Watt resistors are required which are then
must be installed in the cable, see photo C4 1990 not Bose system**

The other end of the resistor is connected to + 12 Volt ignition.

The plug is from the old original radio.

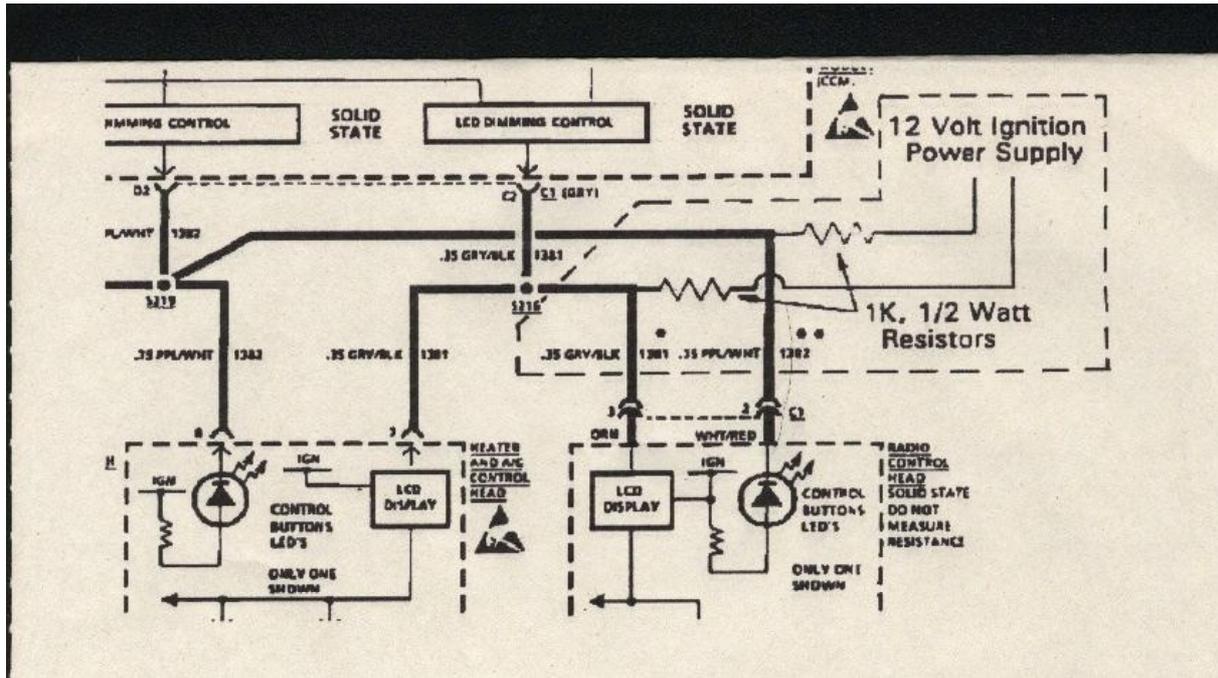
On the 1990-93 Y-car, Diagnostic Trouble Codes (DTC's) 72 and 74 may be set in CCM if an aftermarket radio is installed. "SYS" will be displayed in the LCD section of the cluster, and the DTC's will be displayed when the diagnostic mode is entered.

With an aftermarket radio installed, DTC's 72 and 74 are likely to be set because the LCD and LED dimming lines to the radio have gone to an open circuit, because these inputs do not exist in an aftermarket radio.

1. Disconnect negative battery cable.
2. Remove the radio control head, following the directions in the Service Manual, Section 8C. This will allow access to the radio control head wiring.
