**SYS Meldung im Display
CCM Fehlercode 72 und 74**

Vehicle: All Technical Service Bulletins
Aftermarket Radio May Set DTC'S 72 and 74 In CCM

Number: 93-68-9A

Model and Year:
1990-93 CORVETTE

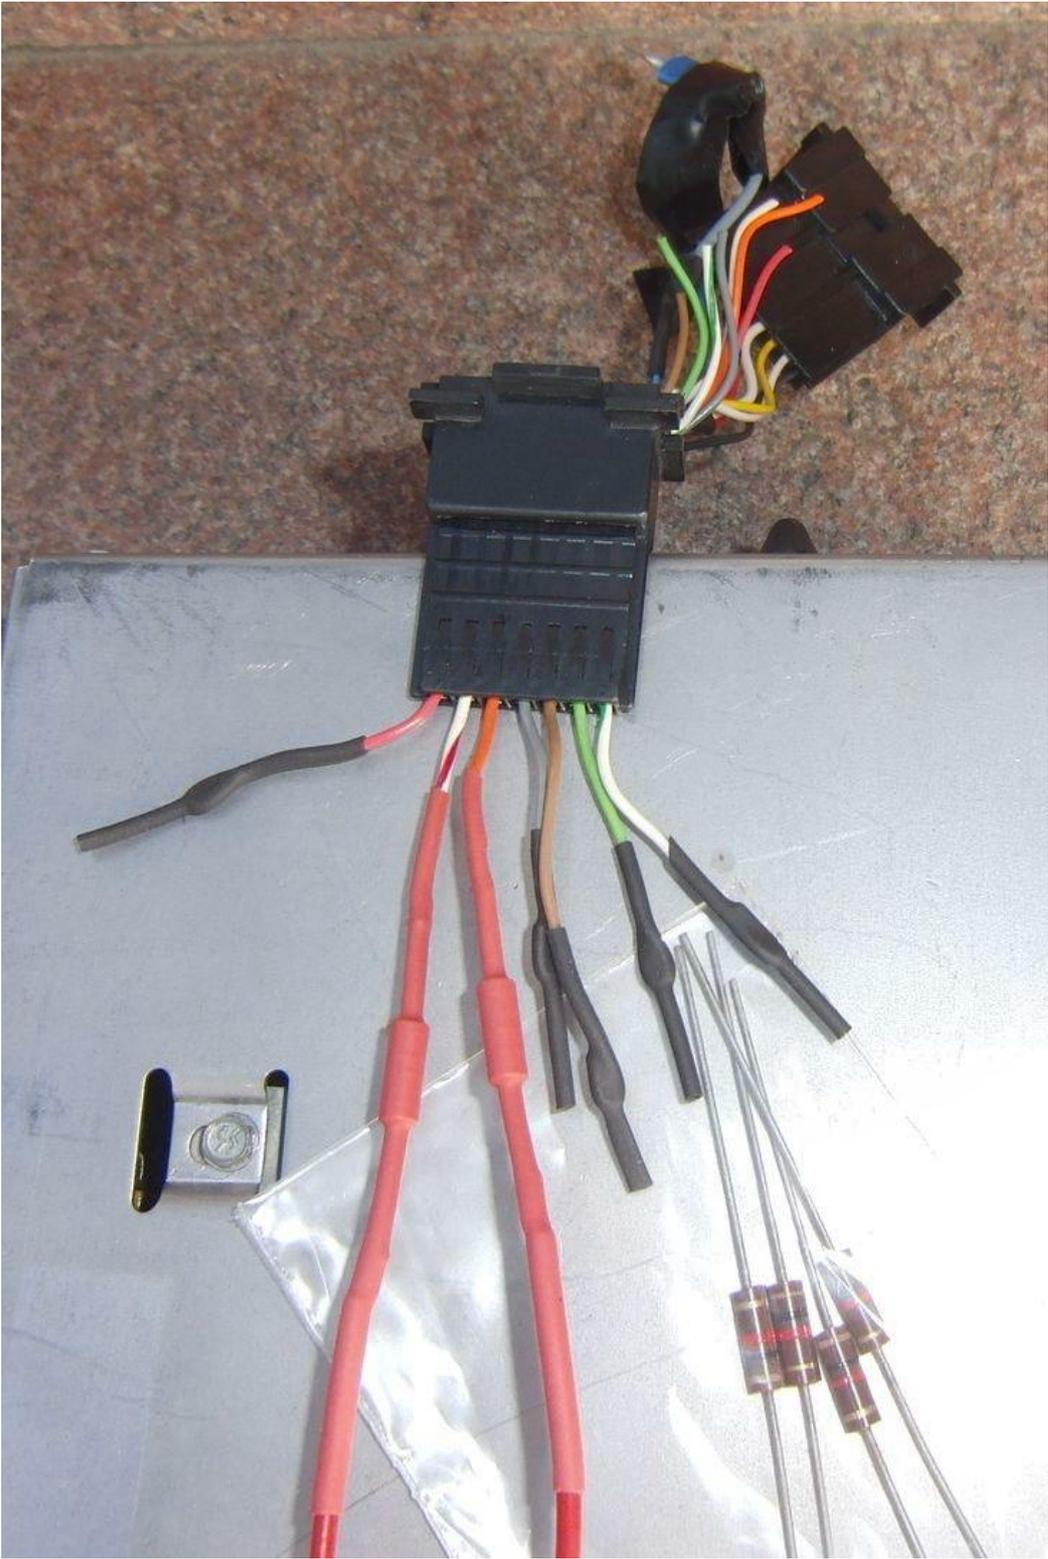
**Es werden zwei 1 k Ohm 0,5 Watt Widerstände benötigt die dann
im Kabel eingebaut werden müssen, siehe Foto C4 1990 nicht Bose System**

Das andere Ende vom Widerstand wird auf + 12 Volt Zündung angeschlossen.

Der Stecker ist vom alten original Radio.
